LifeSpan™ fact sheet

PS LIFESPAN FABRIC Rev. 0
CO# 804

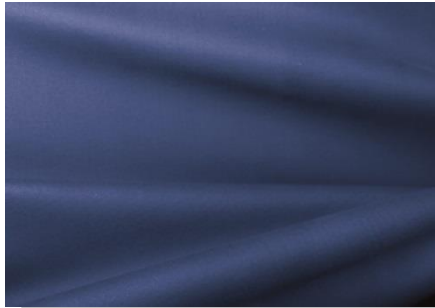
LifeSpan™: coating remains intact

LifeSpan™ fabric provides outstanding protection against hydrolysis. Typical healthcare fabrics become an infection control concern when their coating breaks down after repeated application of harsh chemicals used for cleaning and disinfection.

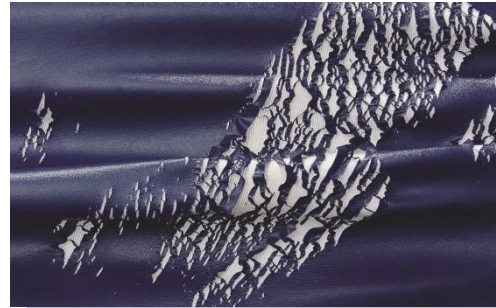
Typical Fabrics: Hydrolysis
